**Preliminary
Report of Findings
Hurricane Harvey Damage**

**Cole & Ashcroft, LP
5631 Brystone Drive
Houston, Texas 77041**

***Project No.: 11992
Date: November 8, 2019
Texas Engineering Firm No. F-11857***

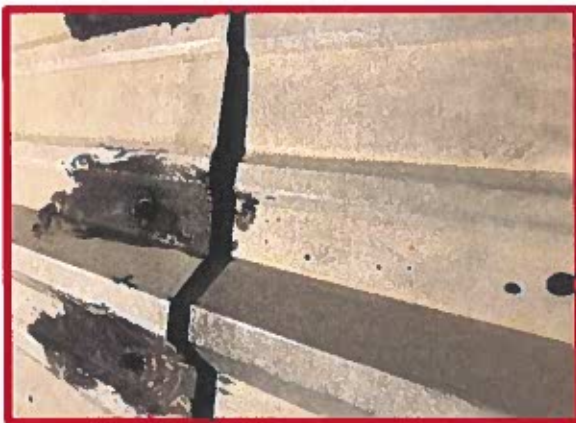
Photograph 20

On the office roof, we observed sealant was applied to all screws. Rubber gaskets pulled off head-wall flashing at taller building wall. There were hail dents and crimps on some roofing panels. Panels were separated at the longitudinal overlap panel joints. Screws were partially separated at overlap panel joints. The following photographs show samples of roof damage.

In our opinion, wind during Hurricane Harvey had sufficient force to cause the observed damage at the Cole & Ashcroft, LP building. As a result of wind damage during Hurricane Harvey, the metal roofs of the office and warehouse, and gutters of the Cole & Ashford, LP building, require removal and replacement.

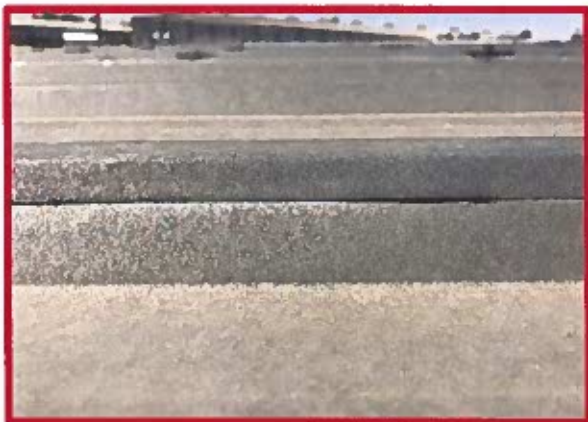
Photograph 39

On the warehouse roof sealant had been applied to the screws. We observed wind bent gutter support brackets, crimped panel seams and hail dents on the roof panels. Panels were separated at the longitudinal overlap panel joints. Screws were partially separated at side joints. There were dents on the metal panel at screws indicating wind lift at on the roof panels. We also observed wind lifted side joints.

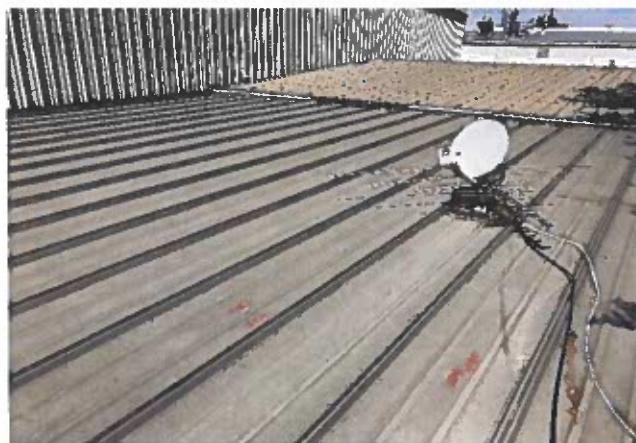
Photograph 4: Office Roof - Left side edge; screws covered with sealant

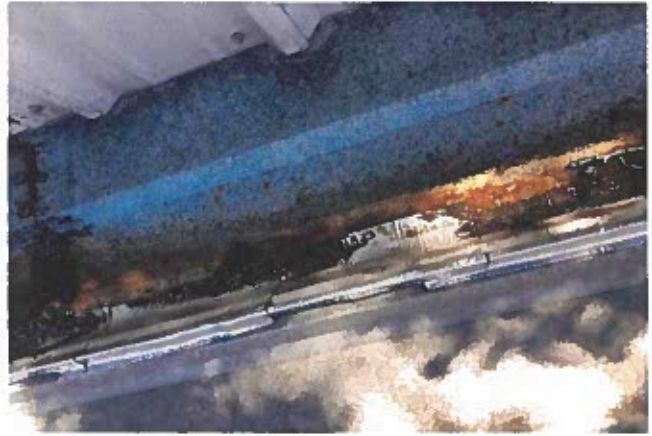
Photograph 7: Office Roof - Right corner at rear building

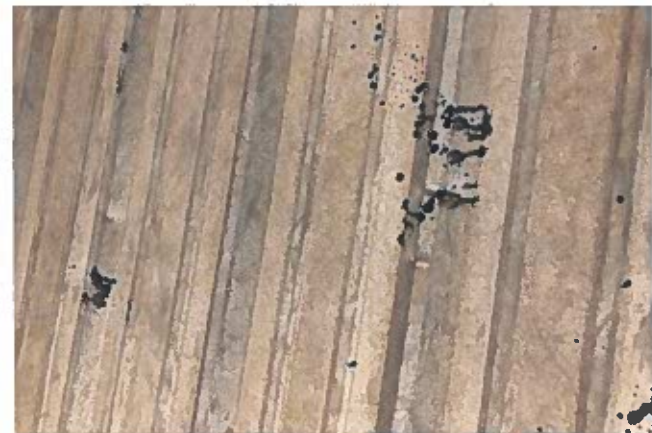
Photograph 11: Office Roof - Crimps on Office Roof; foot traffic

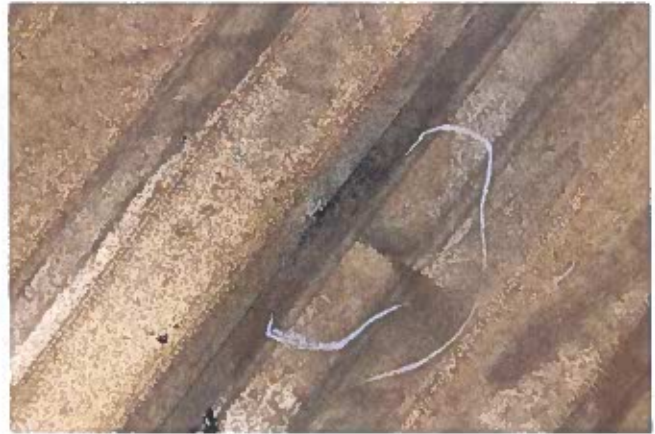
Photograph 13: Office Roof - Crimps on Office roof; foot traffic

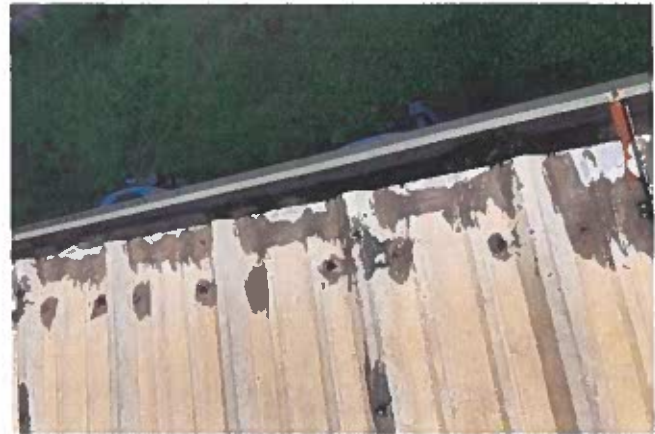
Photograph 15: Office Roof - Crimps on Office roof; foot traffic

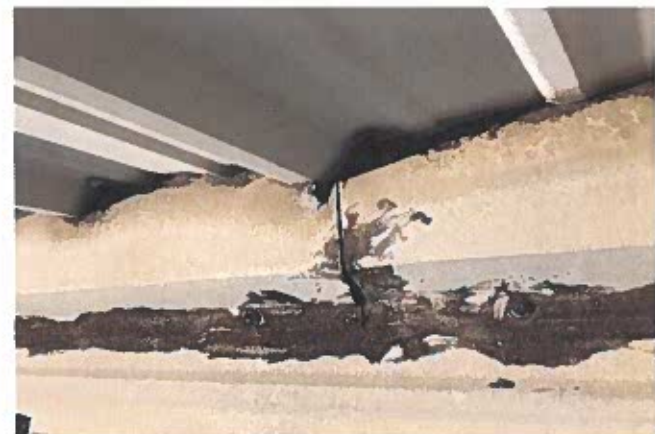
Photograph 17: Office Roof - Loose screw
Sealant applied to vent roof jack

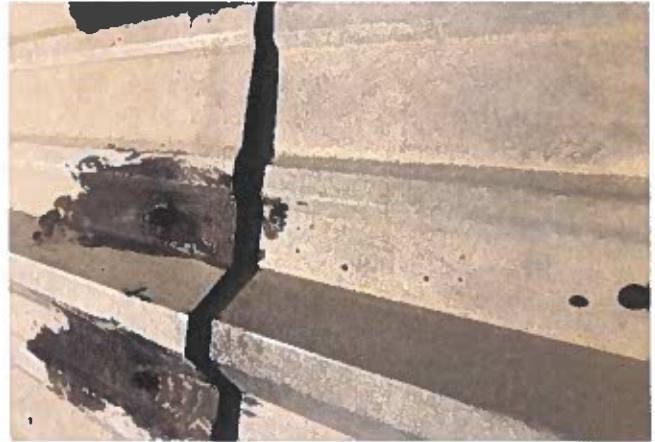
Photograph 19: Office Roof - Sealant applied to flashing at rear building wall

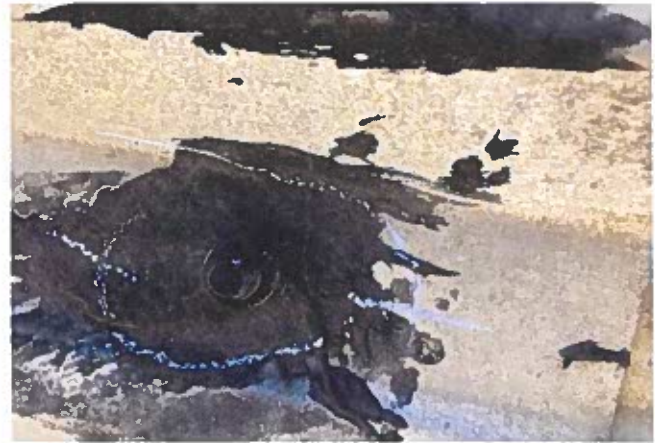
Photograph 21: Office Roof - Wind separated Office roof joint

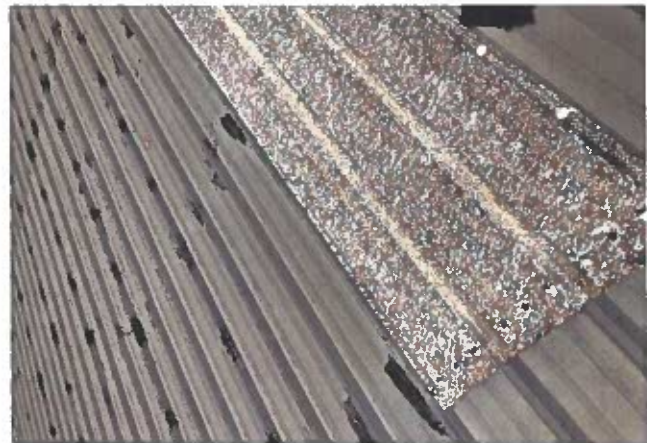
Photograph 39: Warehouse Roof - Wind lifted side joint

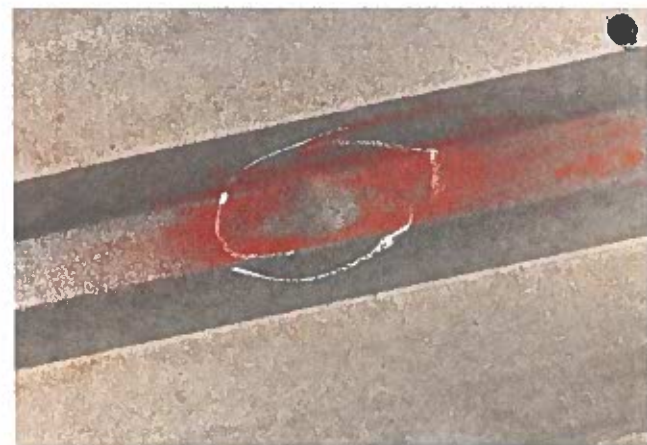
Photograph 41: Warehouse Roof - Hail dent on panel

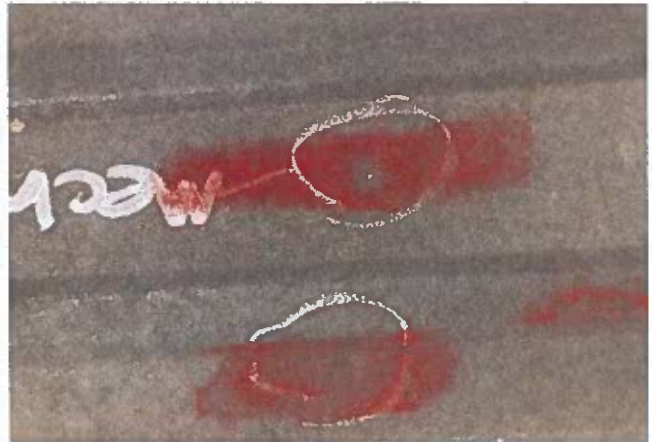
Photograph 43: Warehouse Roof - Hail dent on panel

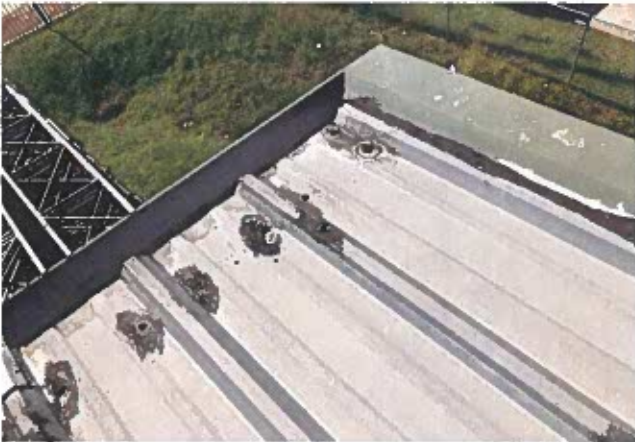
Photograph 49: Warehouse Roof - Missing screws at rear right corner

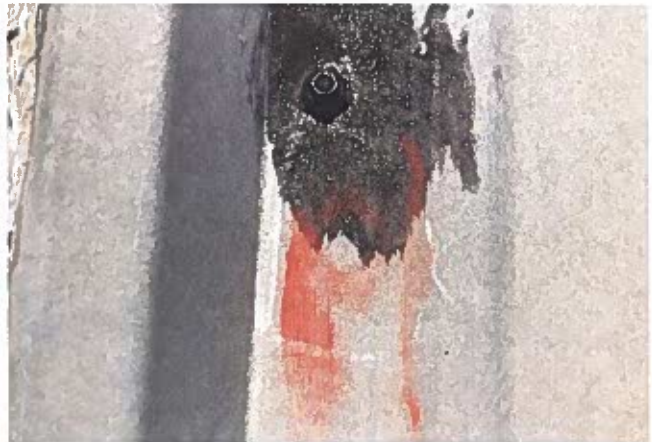
Photograph 50: Warehouse Roof - Screw with dented metal

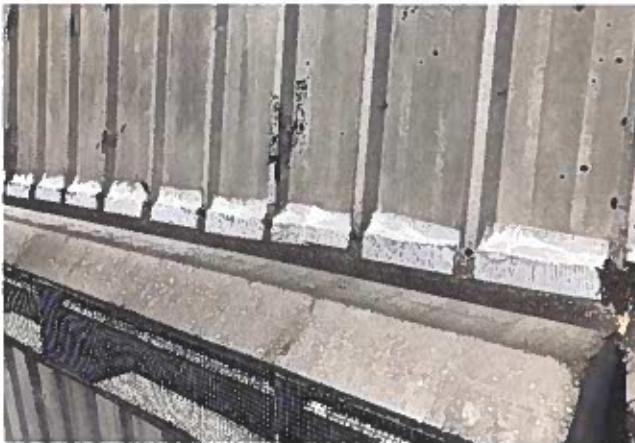
Photograph 51: Warehouse Roof - Taped joint at ridge vent, temporary repair

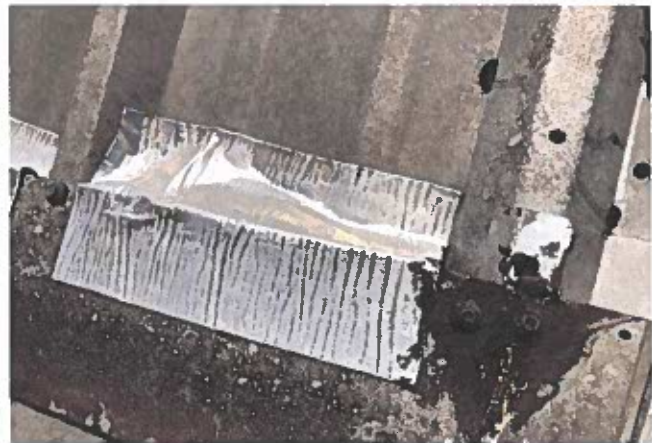
Photograph 52: Warehouse Roof - Taped joint at ridge vent

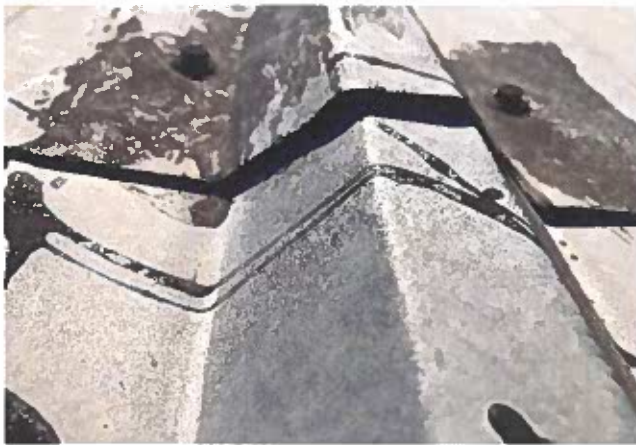
Photograph 57: Warehouse Roof - Wind separated overlap joint

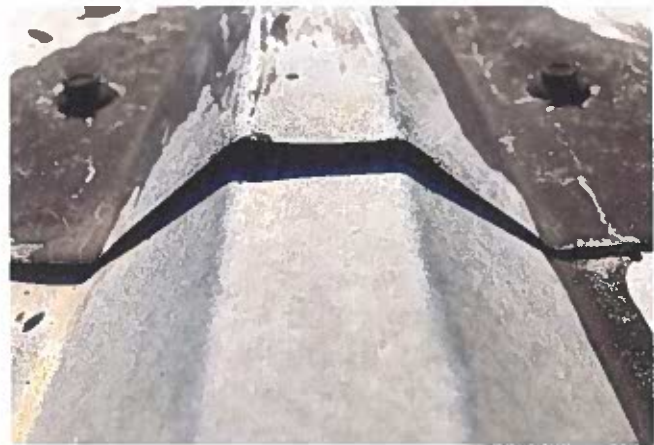
Photograph 58: Warehouse Roof - Wind separated overlap joint

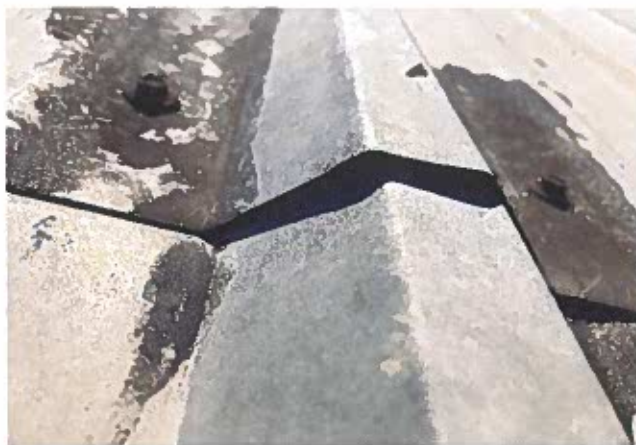
Photograph 59: Warehouse Roof - Wind separated overlap joint

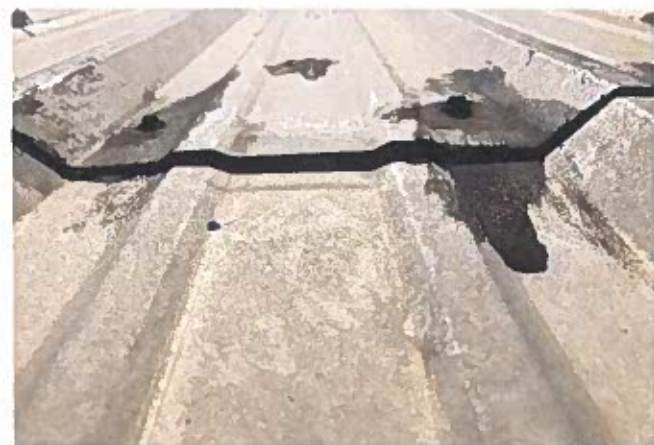
Photograph 60: Warehouse Roof - Wind separated overlap joint

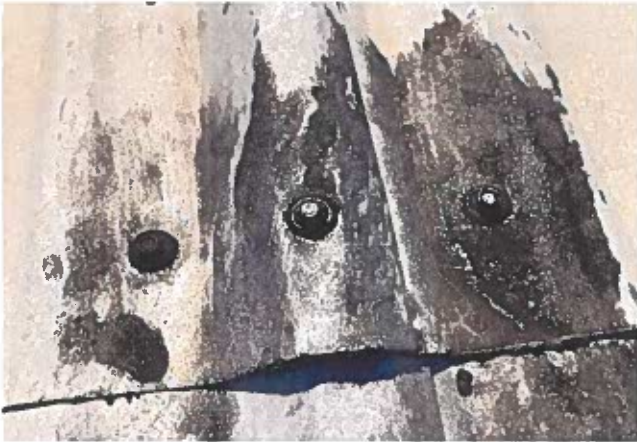
Photograph 79: Warehouse Roof - Wind separated overlap joint

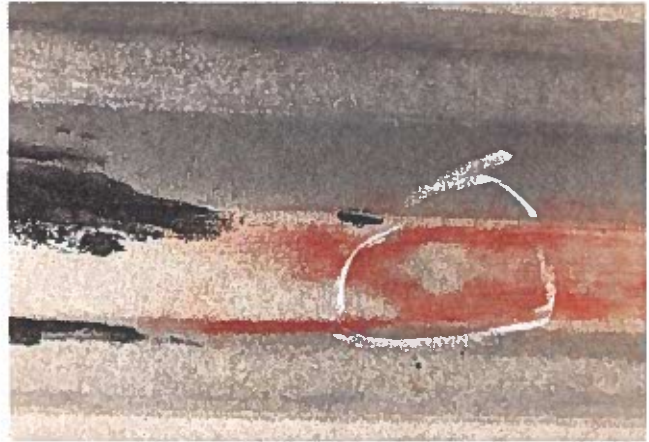
Photograph 80: Warehouse Roof - Hail dent on roof panel

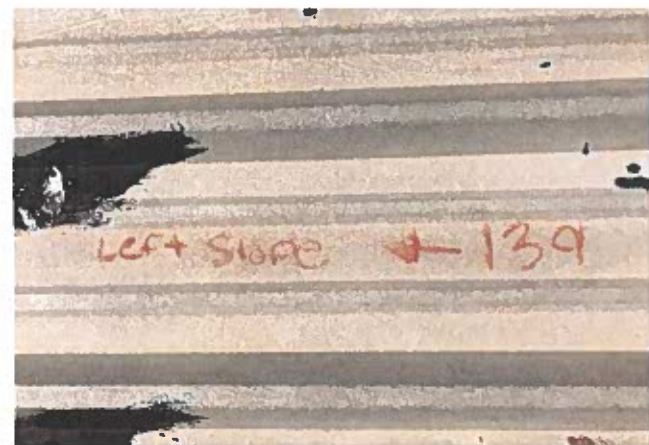
Photograph 84: Warehouse Roof - Left slope; 139 hail dents
